# Canada Post MailBox Report Card

## *Retrofitting Community Mailboxes into Kanata/Beaverbrook*

Thursday, November 20, 2014

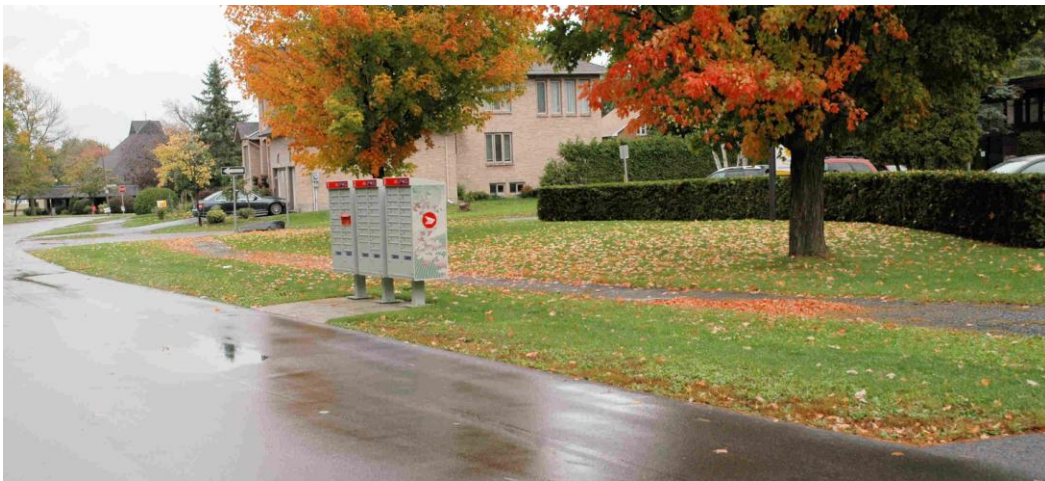
The following is a typical example. The first photo shows that the postbox could have been located anywhere along the strip of grass it sits on.

What is really unclear is why Canada Post placed these mailboxes where they did. In almost all cases there clearly is room for the mailbox to have been located several meters left or right of their current location, which would have resolved this problem.

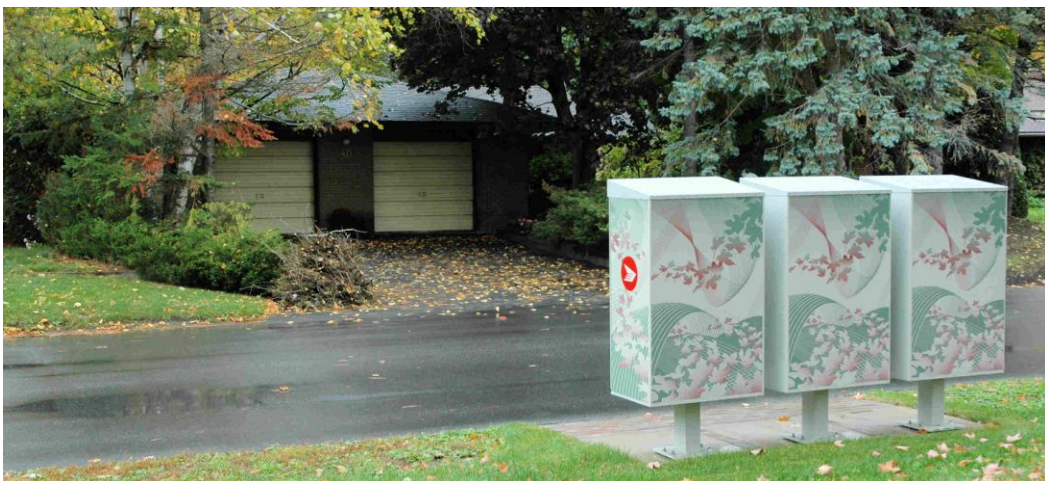
Yet they chose to put it directly opposite this home's driveway.

What is also unclear is why the postbox is not facing the sidewalk/pathway that is directly behind the mailbox, which would provide for safer access and deeper setback.

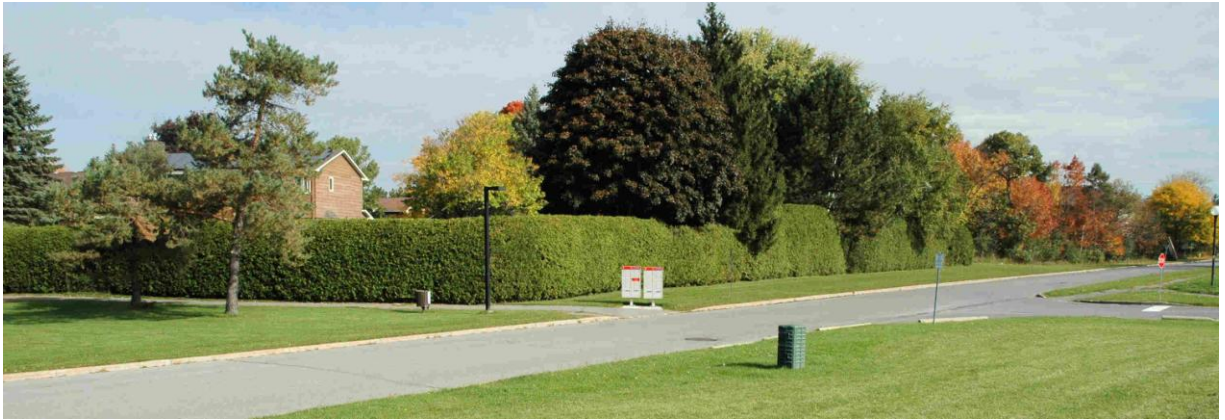
The Community shown below, which is marked as having safety issues in the map, is a very odd and unsafe installation:

This box is near no homes, at the edge of a park, across from the Earl of March High school.

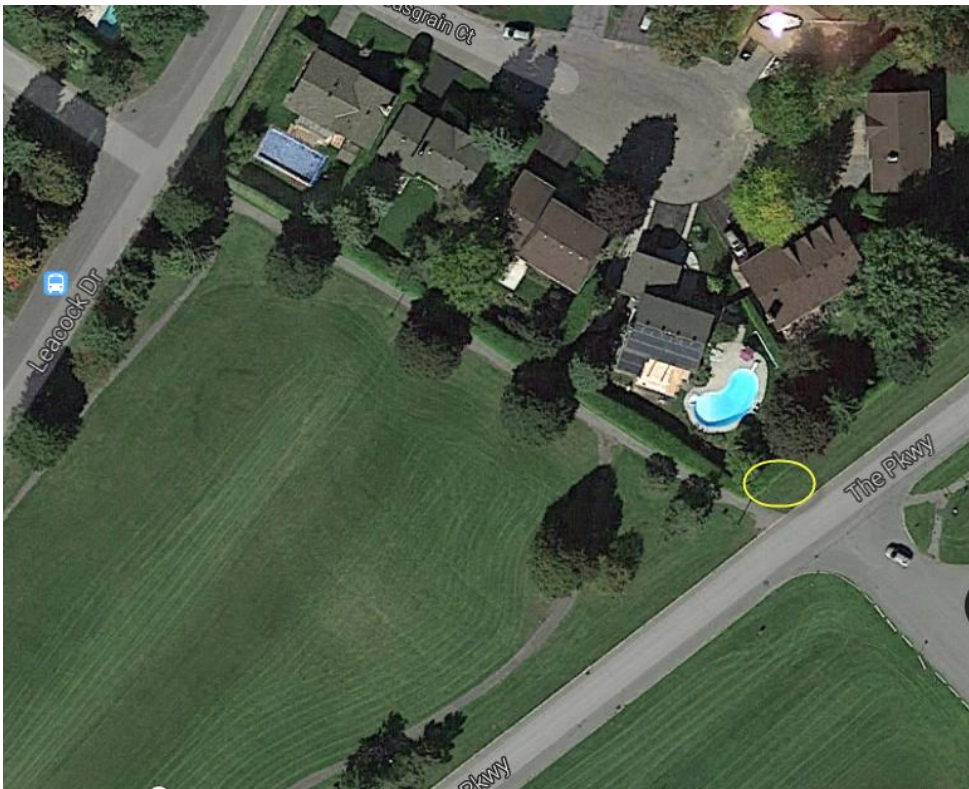
This Google Maps overhead also illustrates the location. The homes that are adjacent are separated by a 20 foot high unbroken hedge both to the North and East, so have no access.

The community mailbox is located on a primary path for students to get to and from the Earl of March High school (grades 9-12) and soon to be intermediate school (grades 7 to 9)

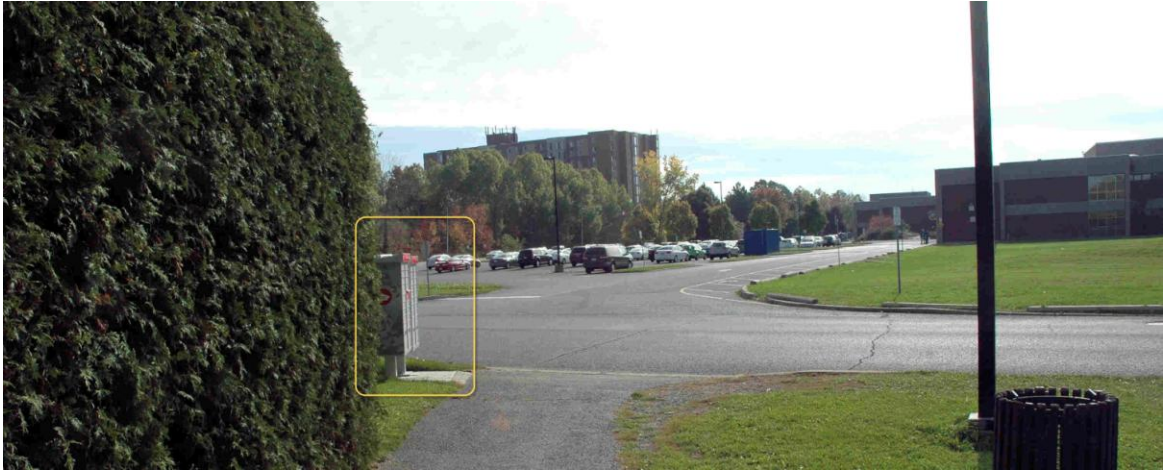
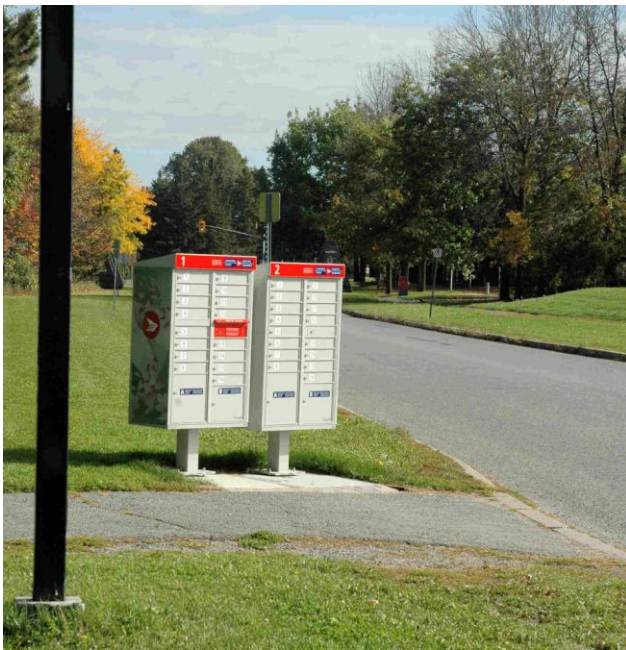
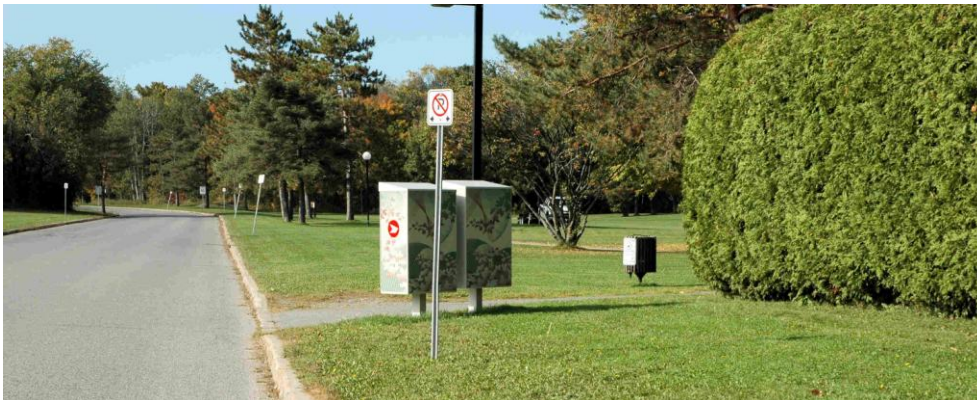
It blocks a pedestrian's view of traffic (coming from the left) as they exit from beside the hedge and in turn blocks the view for drivers of pedestrians.

This will only be aggravated once there are snow banks.

After emailing this report on Nov 13 to a number of Canada Post email personnel via email, we got a response from Canada Post by phone on Nov 14 on this specific issue. They acknowledged the problem and indicated that they would do 2 things. The first is to relocate one of the “pods” to the property of the condo group of buildings at the corner of Teron Road

and the Parkway. This will allow those residents to walk only a few feet to their community mailbox vs. driving to the current location and then doing a U turn. The second “pod” will be located at the other end of the street to service those residents.

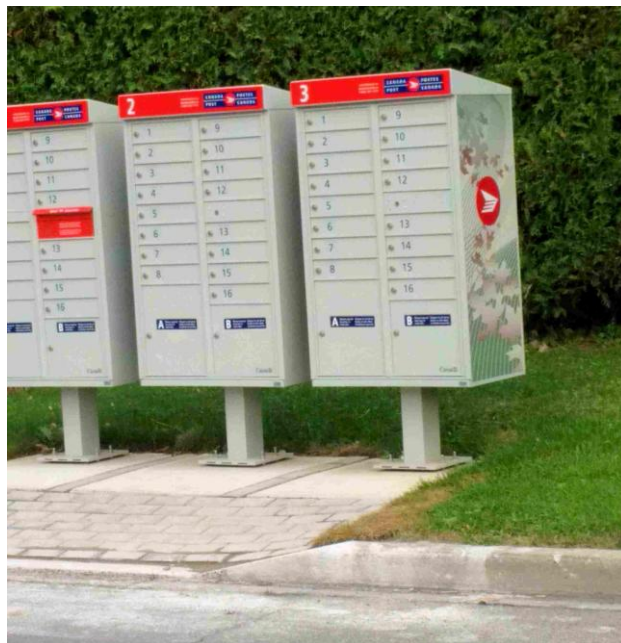
In addition where there is an existing concrete curb, the curb has been cut down to street level with a short, relatively steep ramp and a very shallow flat area immediately in front of the postboxes. It is easy to see inadvertently stepping back onto the ramp when swinging open a postbox and falling over backwards, particularly in winter. This is particularly a concern for wheel chair accessibility. The following is one example:

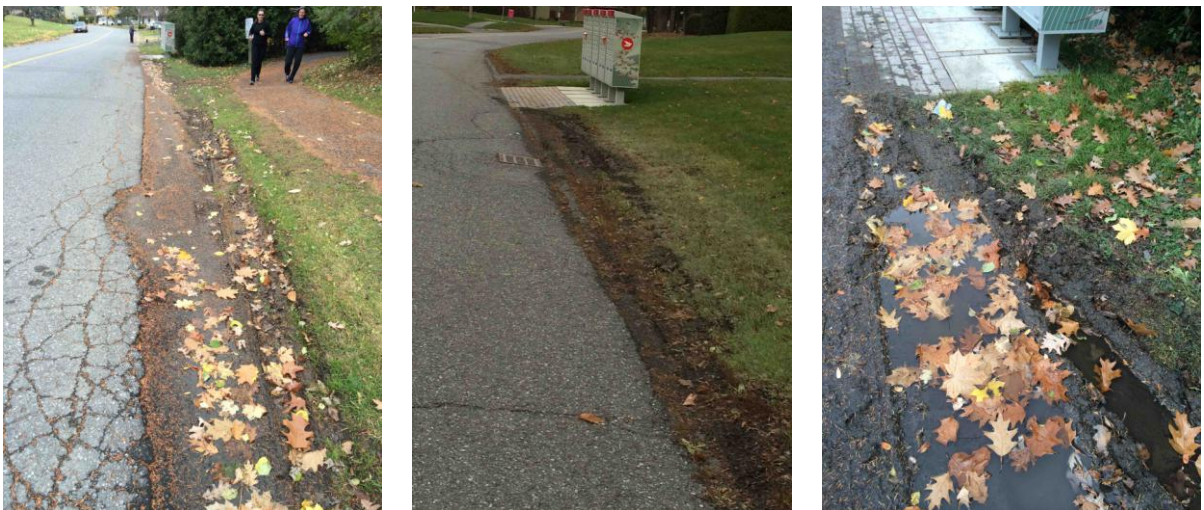
Less than a month after the community mailboxes were installed in Beaverbrook, we are seeing property damage due to residents who drive to pick up their mail parking with two wheels on the grass verge due to safety concerns on busy residential streets, which is possible in communities without roadside curbs

Clearly residents feel the need to drive onto the grass verge because they do not feel safe exiting their cars on a busy collector near locations where there are curves in the road and multiple intersections. Cars turn onto Penfield quickly and generally are travelling close to the speed limit. Drivers have little time to react if a car door opens. Most people who are driving to the boxes probably stop on the way home in the evening, when it is dark and there is naturally more traffic. The lack of street lighting at these locations further adds to the fear of not being visible.

The sequence from left to right shows the week to week deterioration in only 3 weeks.
